Sheet 1	Surveyor AVS	Certificate AVS	System Owner
Revised By	Reviewer #	Work Order	
Customer		PO	Media Label
Date 20240216 05:49	Weather	PreClean Light Cleaning	Date Cleaned
Flow Control		Purpose	Direction Downstream
Inspection Status Complete Inspection		Consequence of Failure	Pressure
Inspection Technology Used	<input type="checkbox"/> CCTV <input type="checkbox"/> Laser <input type="checkbox"/> Sonar <input type="checkbox"/> Sidewall <input type="checkbox"/> Zoom <input type="checkbox"/> Other		
Street XXXXXX Ave.	City Chicago	Drainage Area	
Location		Pipe Use Sanitary Sewage Pipe	
Details		Height 8	Width in
Shape Circular	Material Cast Iron	Lining	
Coating	Joint Length ft	Total Length 38.6	ft
Len. Surveyed 38.6 ft	Year Constructed	Year Rehabilitated	
Up Parking lot	Rim Invert	Grade Invert	Rim Grade ft
Northing	Easting	Elevation	
Down street	Rim Invert	Grade Invert	Rim Grade ft
Northing	Easting	Elevation

Sheet 1	Surveyor AVS	Certificate AVS	System Owner
Revised By	Reviewer #	Work Order	
Customer	PO	Media Label	
Date 20240415 10:50	Weather	PreClean No Pre-Cleaning	Date Cleaned
Flow Control	Purpose	Direction Downstream	
Inspection Status Complete Inspection	Consequence of Failure

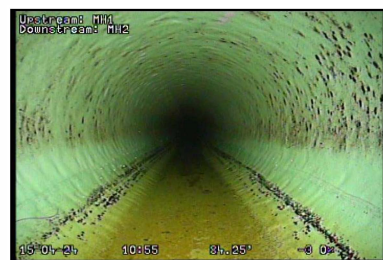
84.3 Miscellaneous Water Level

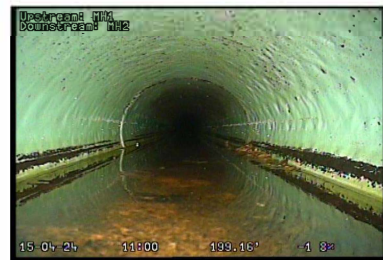
199.2 Miscellaneous Water Level

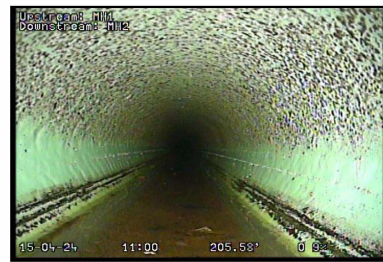
205.6 Miscellaneous Water Level

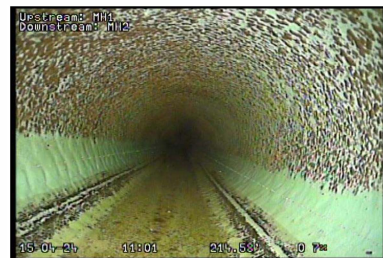
214.7 Miscellaneous Water Level

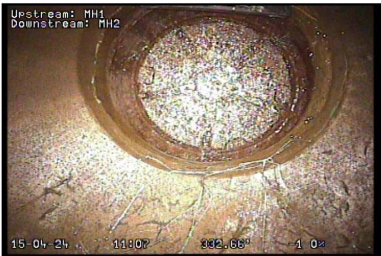
332.7 Miscellaneous General Obser

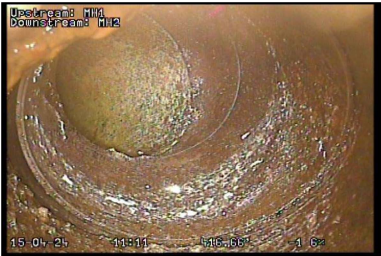
416.7 Tap Factory

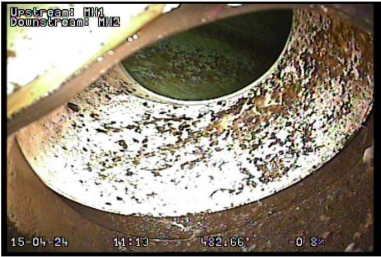
482.7 Tap Factory

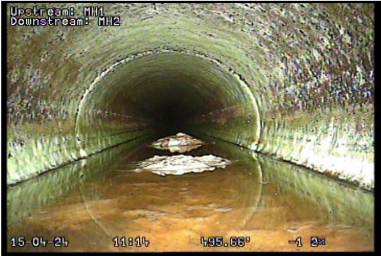
495.7 Miscellaneous Water Level

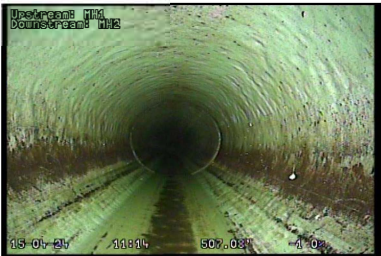
507.1 Miscellaneous Water Level

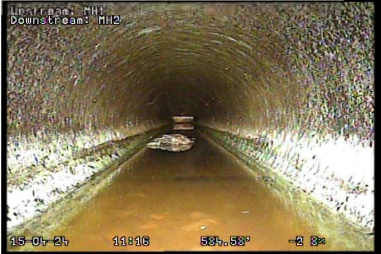
584.6 Miscellaneous Water Level

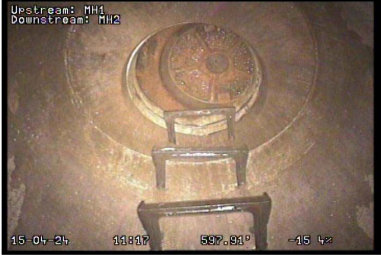
598.0 Manhole
